THE UNITED REPUBLIC OF TANZANIA
MINISTRY OF WATER

**UPDATED ENVIRONMENTAL IMPACT STATEMENT FOR THE
PROPOSED CLIMATE RESILIENT WATER SUPPLY PROJECT IN
BUSEGA, BARIADI AND ITILIMA DISTRICTS, SIMIYU REGION**

DRAFT REPORT

Location: Busega, Bariadi and Itilima Districts, Simiyu Region

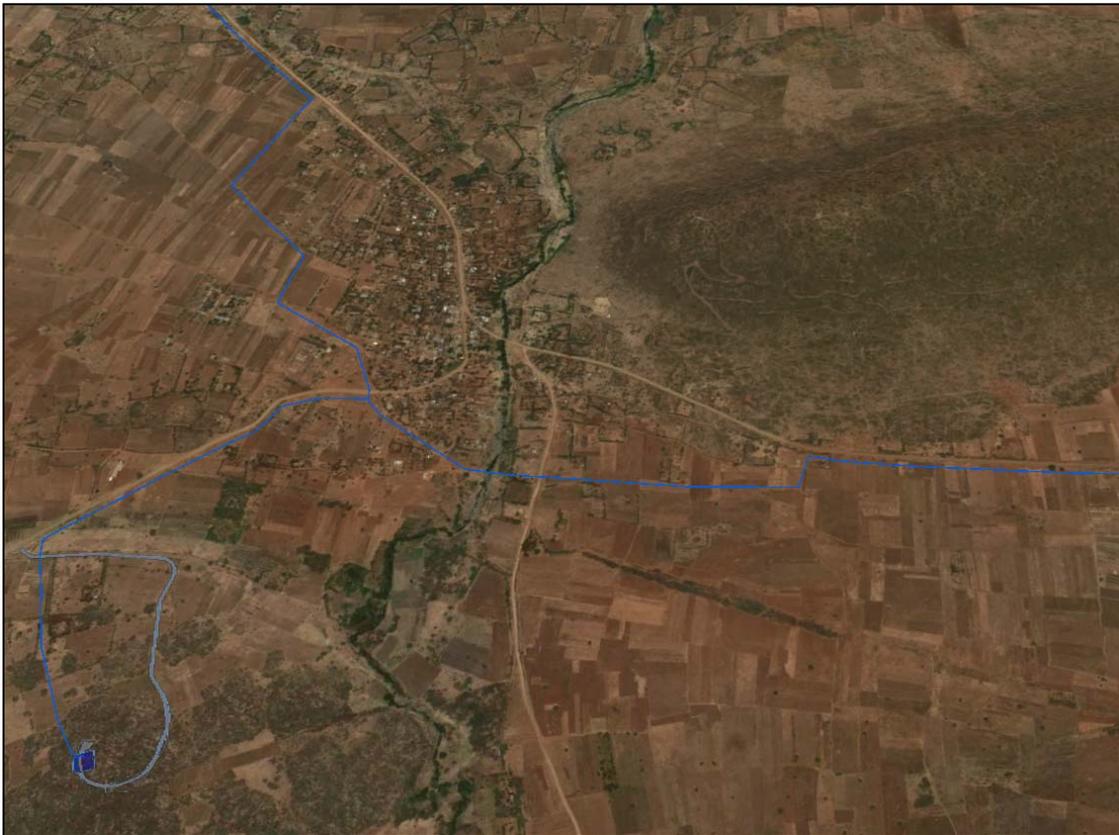
Figure 5: Location of Isadukilo primary reservoir (lower left corner) and Ngasamo bypass.
(Blue line: gravity main; grey line: new access road)

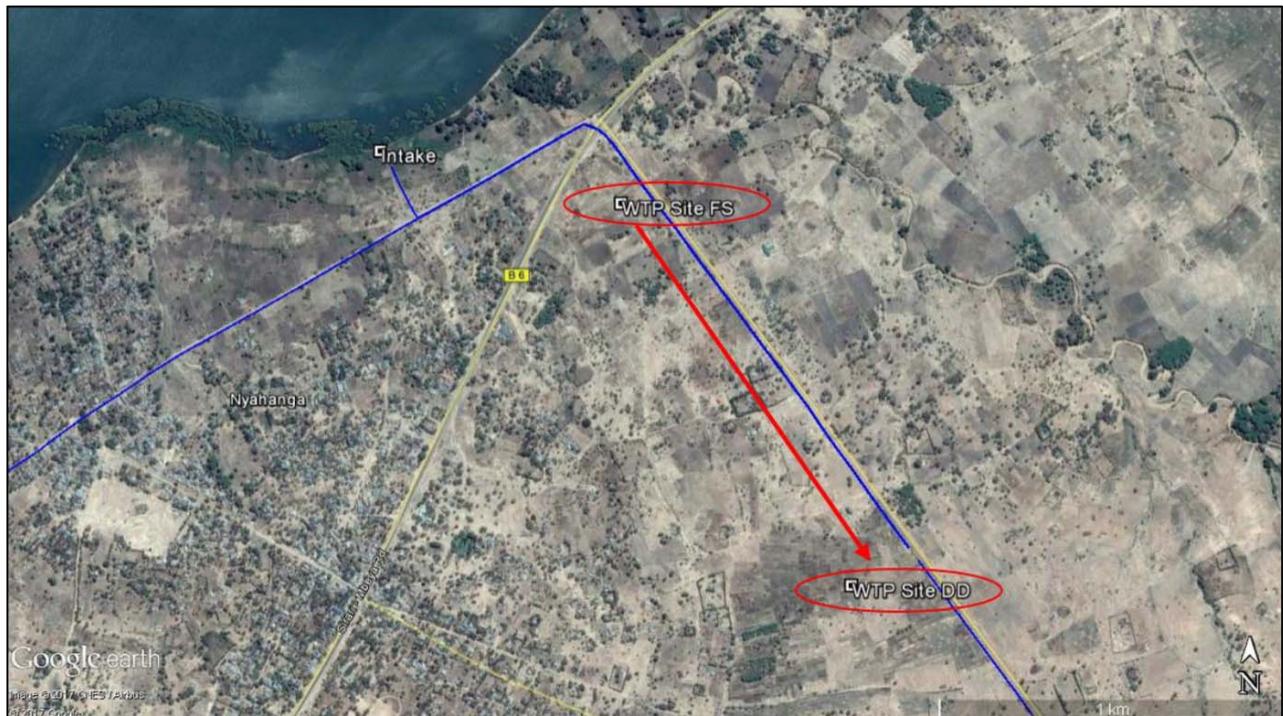
Figure 9: Changed location of the water treatment plant at Bukabile.

The new site for the water treatment plant at Bukabile has similar characteristics as the previously proposed piece of land. It is a fairly flat parcel of land situated along the main road. There are no residential structures

but the land is cultivated and seasonally grazed by livestock. The total land required for the water treatment plant is 10 ha. The land is privately owned.

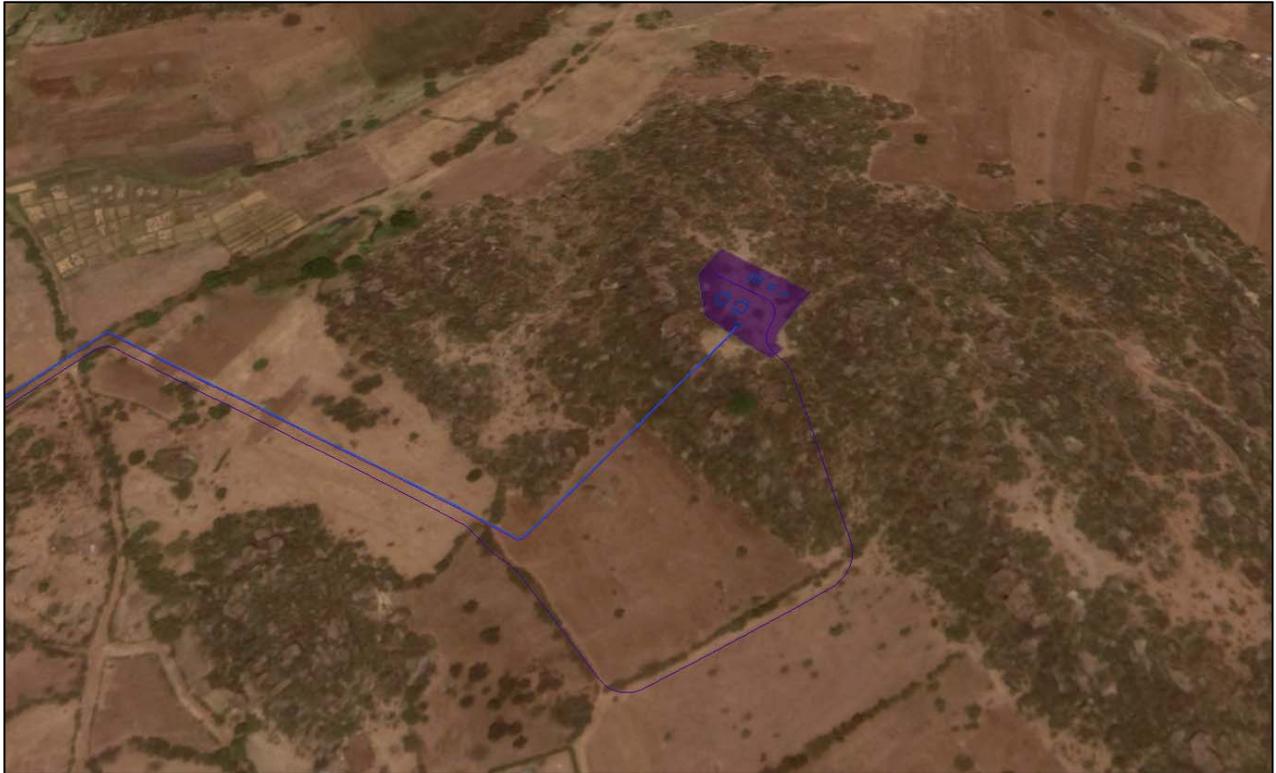
Figure 10: Google Earth view of Isenge hill with the planned infrastructure.

Isenge primary reservoir (for water supply to Dutwa) has been proposed at the top of Isenge hill. According to the ESIA Report, Isenge hill is a sacred site where rituals and ceremonies are held. People from Dutwa and even from far away go there to ask for rain when there is drought, to ask for forgiveness, to ask for blessings and all other things that need divine power. The ESIA recommended that “the siting of the primary reservoir at Isenge holy hill must be agreed with traditional leaders or be shifted to another suitable location.”

In order to follow up on this recommendation, a consultation meeting was held with the village chairman and other local representatives and community members on 15 February 2019. It was then revealed that the rituals and ceremonies are done at the chief grave and clan burial site on the northern slopes of the hill. According to the local leaders, the proposed water reservoir on top of Isenge hill would not interfere with the place where they conduct the rituals and ceremonies. They had also no objection to having the access road and water pipes passing on the south/south-west slope of the hill (where they have been proposed). The minutes of this meeting are enclosed to the updated Stakeholder Engagement Plan (see separate volume).
