THE UNITED REPUBLIC OF TANZANIA

Ministry of Water

## Lake Rukwa Basin Water Resources Key Figures

## Lake Rukwa Basin Water Infrastructure Key Figures

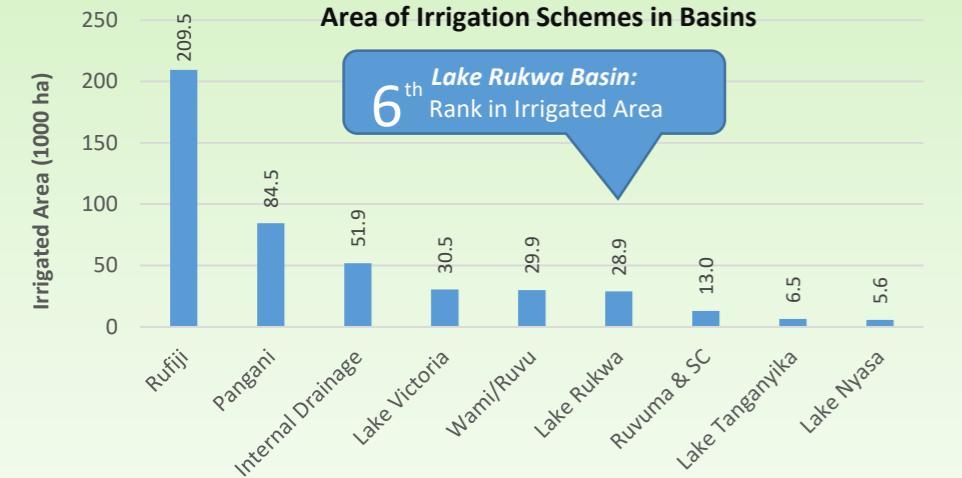
Lake Rukwa Basin

1%

Domestic (54 mcm)

Irrigation (532 mcm)

Hydropower (0 mcm)

Industries & Mining (5 mcm)

Livestock & Aquaculture (13 mcm)

Ecosystem & Wildlife (4676 mcm)

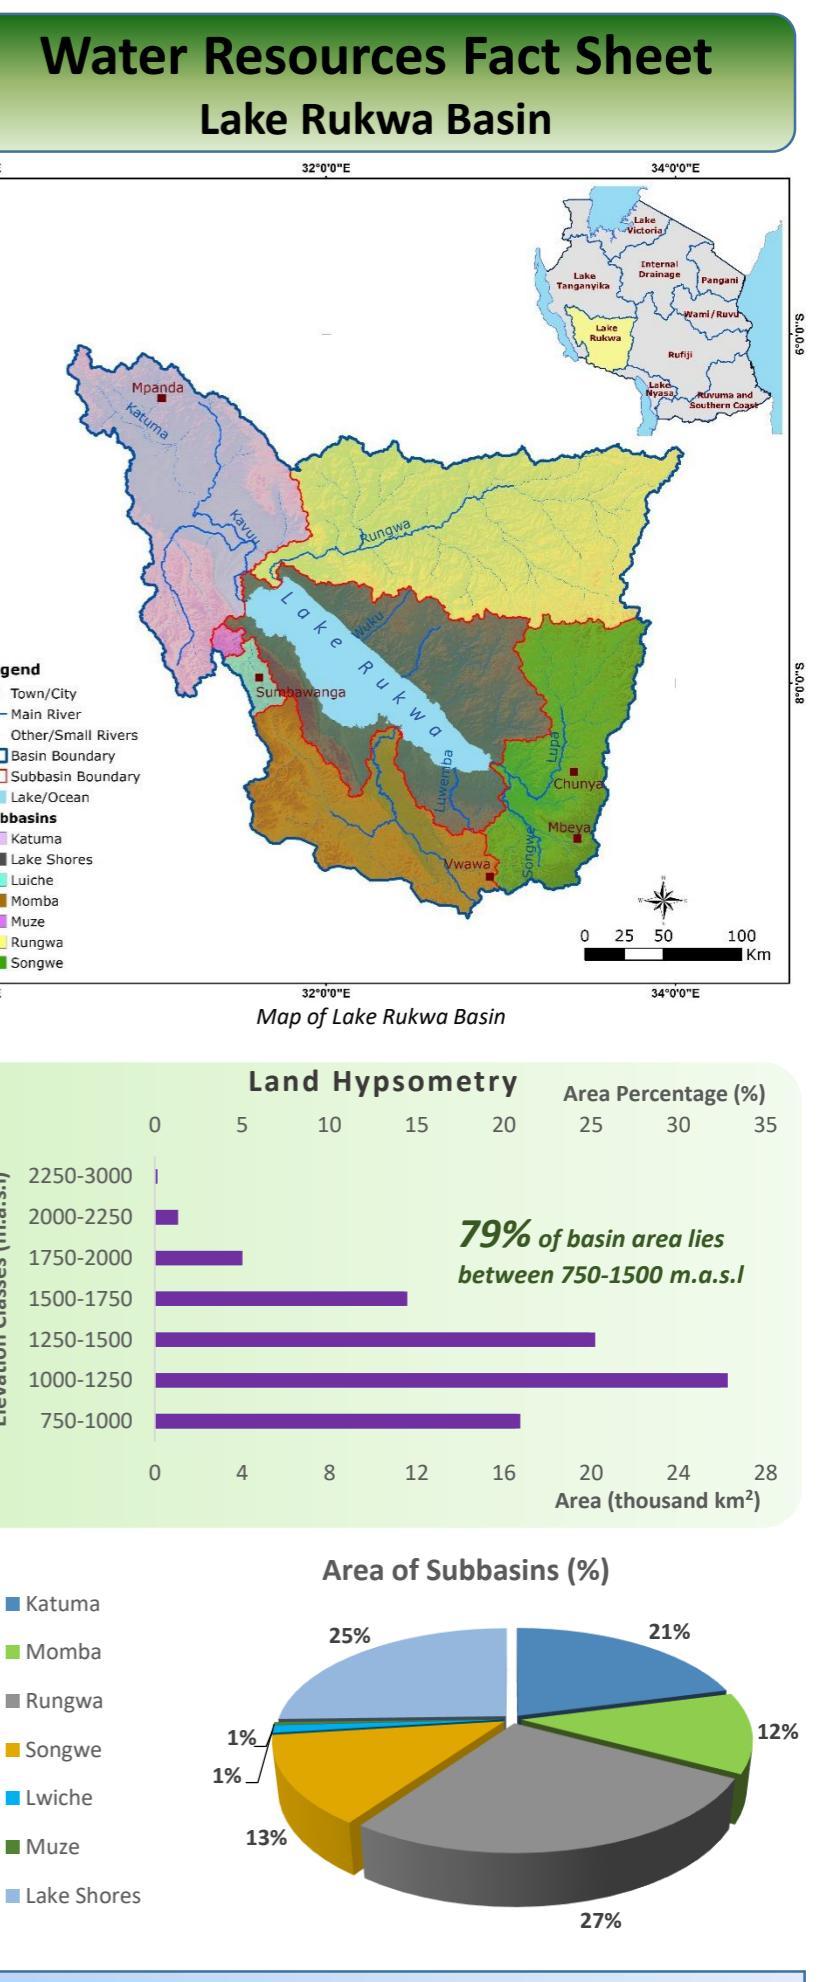
Tanzania mainland is comprised of nine hydrologic basins. Lake Rukwa Basin occupies 8.4% of the area of the country, accommodating about 5% of mainland's population. The basin is in the form of a closed watershed that drains internally into Lake Rukwa. Located in the southwest Tanzania, Lake Rukwa Basin crosses the border with Zambia.

Legend Town/City - Main River Other/Small Rivers Basin Boundary Subbasin Boundar Lake/Ocean Subbasins Katuma Lake Shores
